NATIONAL PROGRAM FOR INSPECTION OF NON-FEDERAL DAMS
FLYING POND DAM (ME-0. (U) CORPS OF ENGINEERS WALTHAM
MA NEW ENGLAND DIV APR 79

Flying Bomb Ram ME-00299
DOCUMENT IDENTIFICATION April 1979

Flying Pond Dam

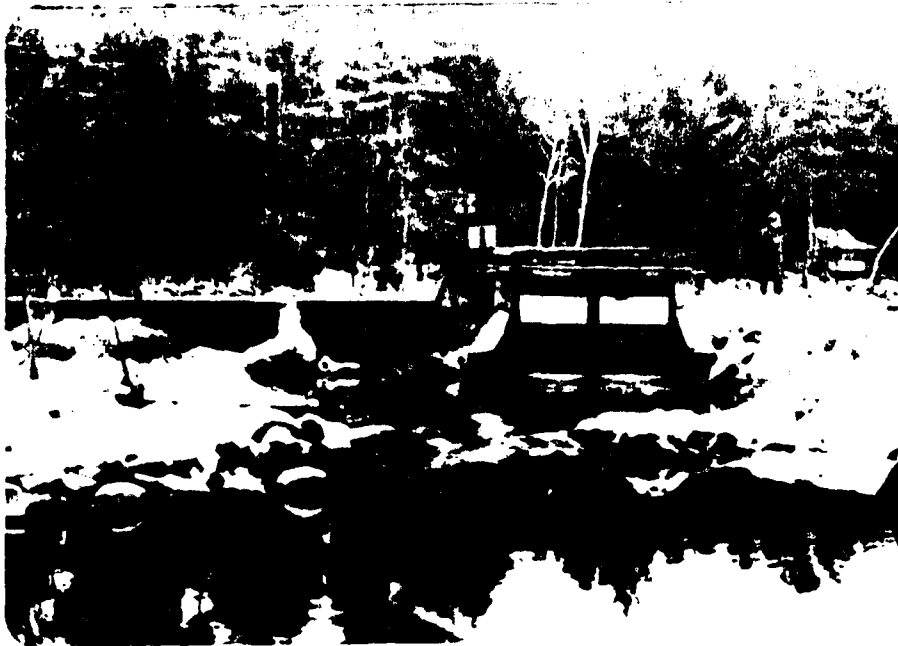
The surface of the spillway and the surfaces of the controlled outlet were found to be in good condition with no evidence of erosion, spalling, or leakage (see photos no. 3 and 4).

3
DOWNSTREAM FACE

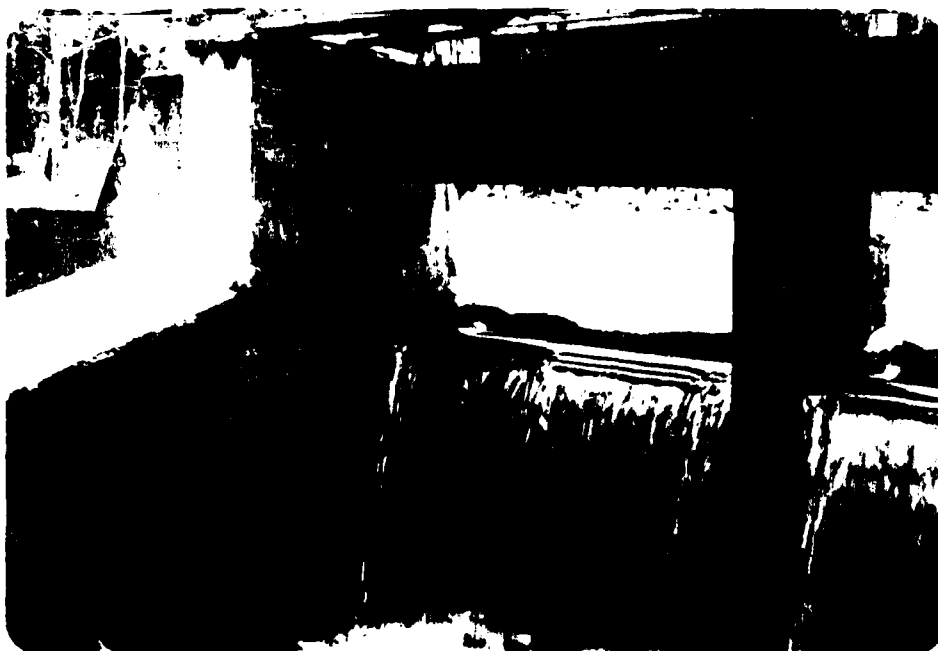
4
STOP LOGS AT STOP LOG OUTLET

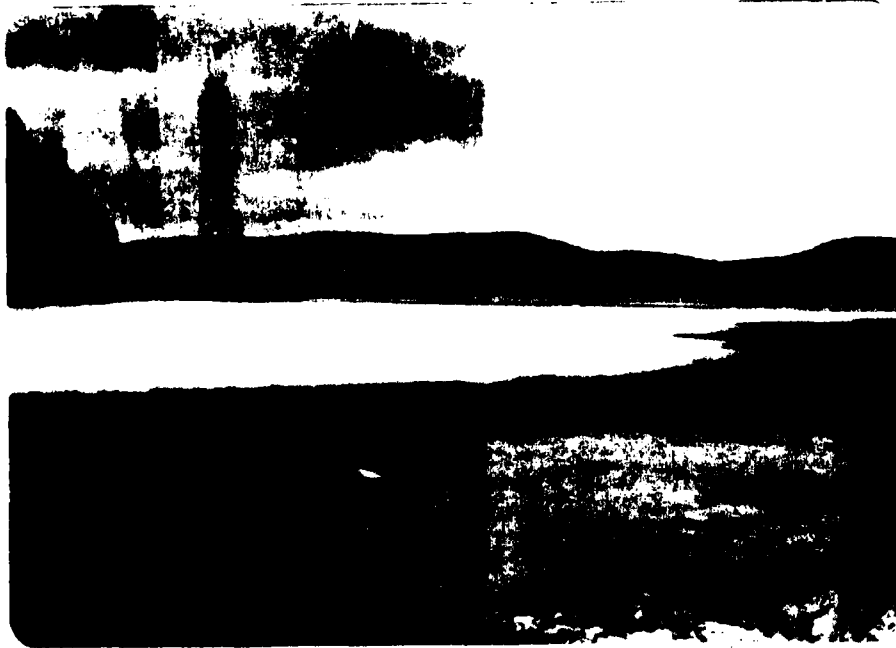
Upstream Channel - Flying Pond comprises the approach channel to the spillway (see photo No. 1). This channel is generally clear and unobstructed. The inlet area to the stop log bays is partially clogged with sand bags placed to reduce leakage.

1
VIEW UPSTREAM

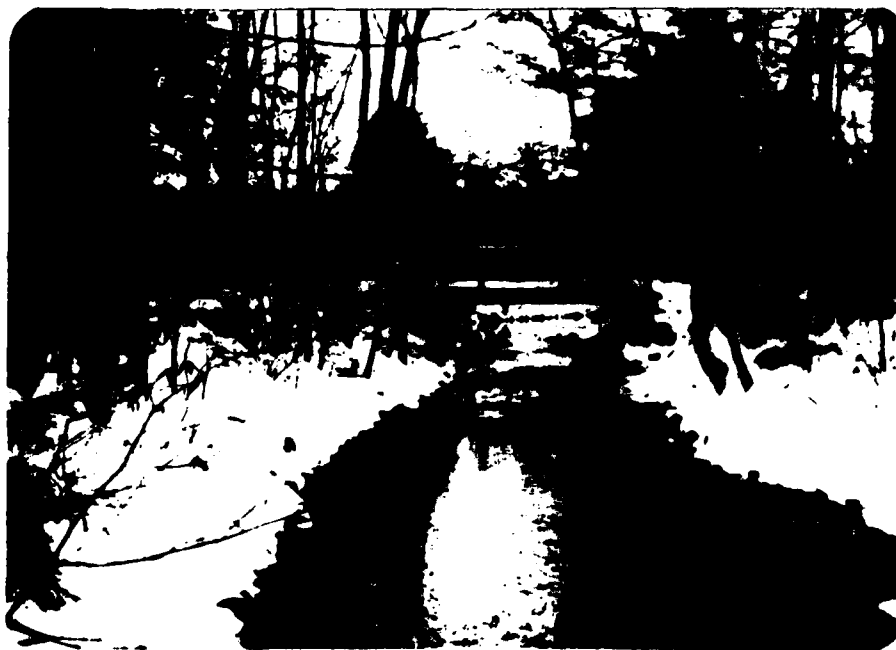
2
VIEW DOWNSTREAM

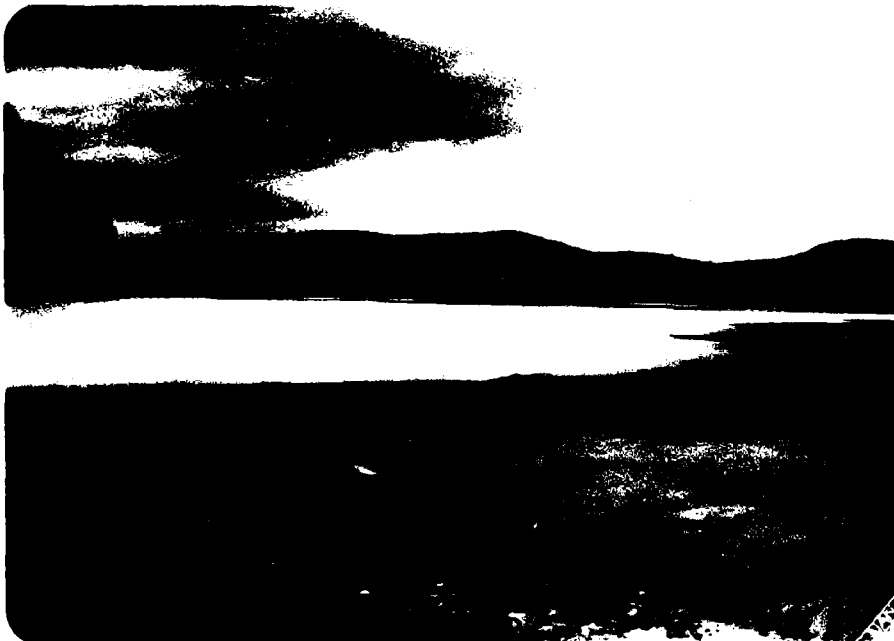
1
VIEW UPSTREAM

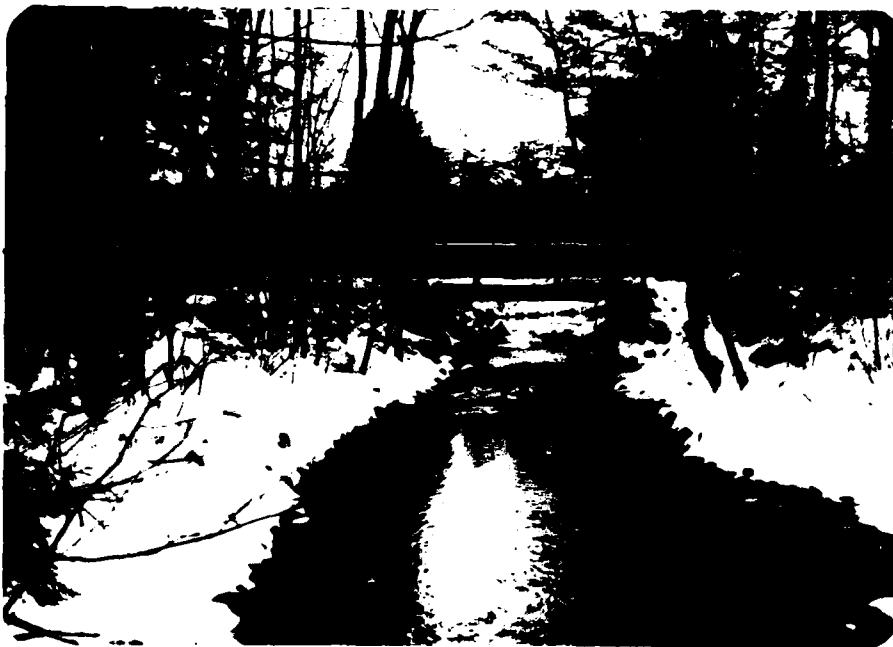
2
VIEW DOWNSTREAM

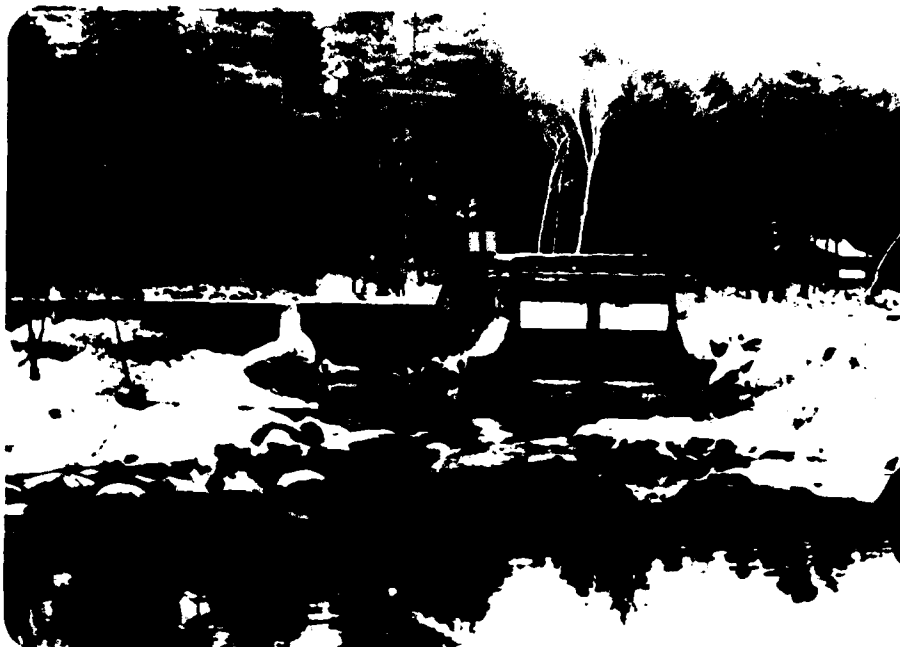
3
DOWNSTREAM FACE

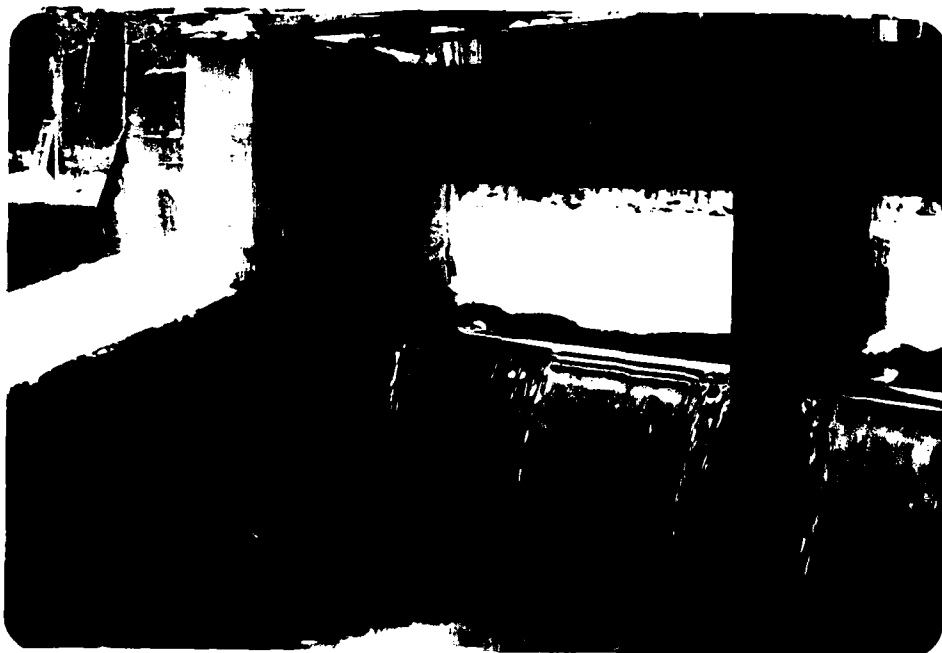
4
STOP LOGS AT STOP LOG OUTLET
